The A and C Structures

CAPSULE STORAGE BUILDINGS - 908 and 941

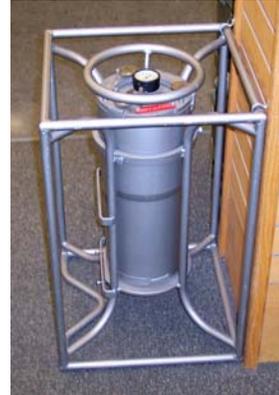
M-102 Bird Cage
(National Atomic Museum)

The A structures on Stony Brook stored nuclear components (capsules) in pressurized M-102 "bird cages." The 'bird cage' structure was designed to prevent the nuclear materials from coming in close proximity to each other which might have initiated a chain reaction. These A structures were considered hardened structures, some additionally shielded by bermed earth. For the windowless above ground A structure, a second story actually provided more protection through its 17 feet of solid reinforced concrete.

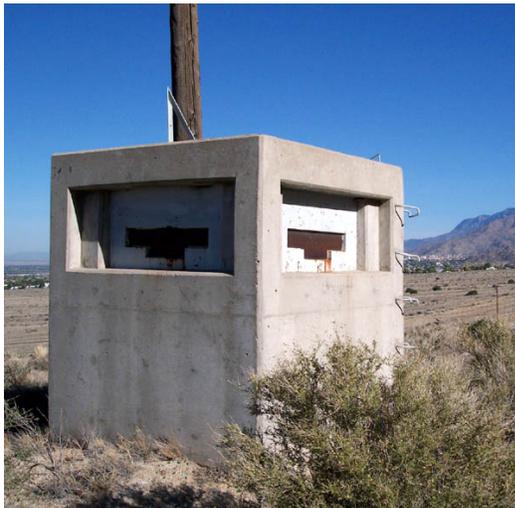
Pill-box at Manzano Base, NM. Identical to those on Stony Brook near capsule storage.

The A structures on Stony Brook were Buildings 908 and 941. One or more small guard houses ("pill boxes") were built in close proximity for security purposes. These "pill boxes" were common wherever nuclear capsules were stored.

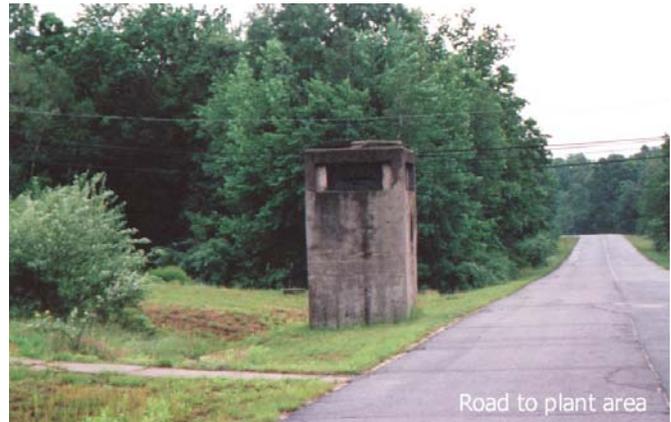
Pill-boxes manned during alerts, etc. There were 2 of these, one was on the opposite side of the road, see photo on next page.

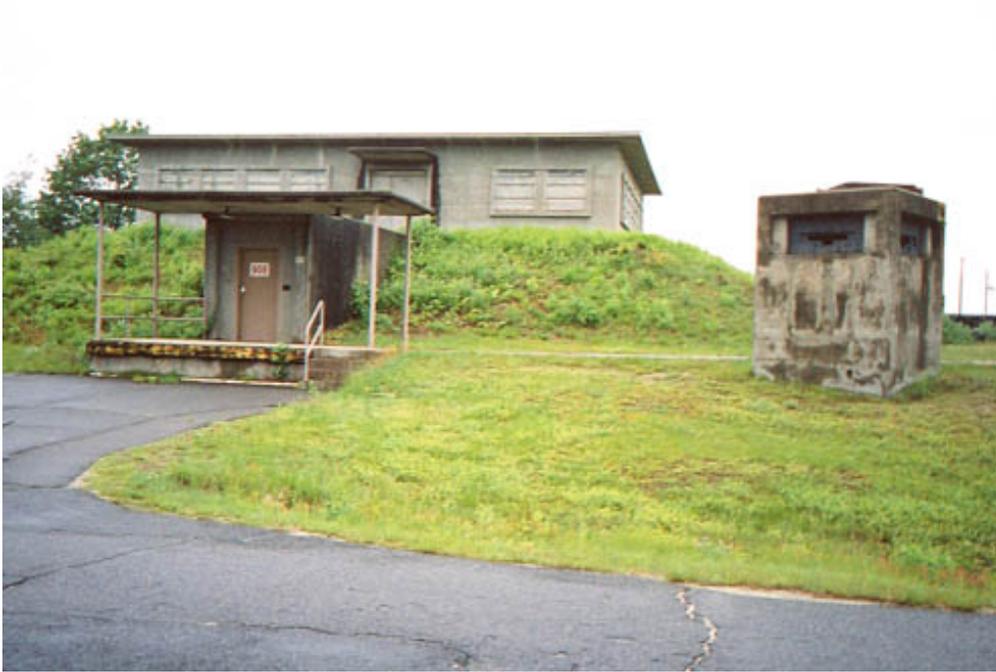
The newer Building 908 where nuclear capsules were stored. The upper structure was a fake building made of solid concrete. The lower entrance led to a vault door that accessed a corridor with 2 doors on either side. These were bank-type vault doors, not blast doors.
(Photo by Clarke Ketter, copyright 2004)

For the newer A structure at Stony Brook, the storage space for the capsules is entirely bermed or below ground, with a false single story above ground (solid reinforced concrete). The older A structure gave the appearance of an office building when viewed from a distance through the addition of bands of paired false windows and a projecting entrance offset. The bermed A structure was less convincing in this regard from a near perspective, due to the mounded earth and the resultant tunnel-like extension of the offset on one facade.

In the newer A Structure on Stony Brook, the storage bins were 30 inches wide, as compared to 36 inches in the older structure. This reduction in bin size was a result of a change in the composition of the nuclear capsules which allowed them to be stored closer together without the danger of initiating a chain reaction.

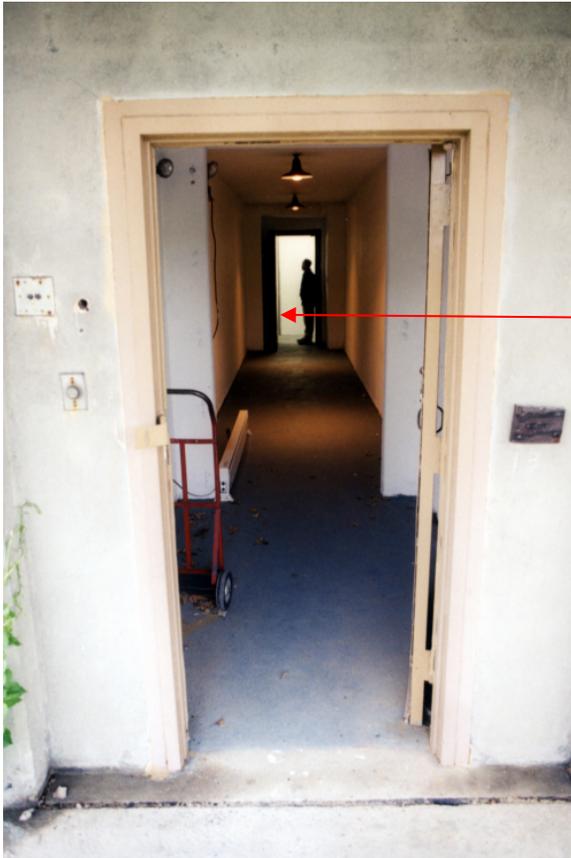
Corridor in building leading to first vault door (right).

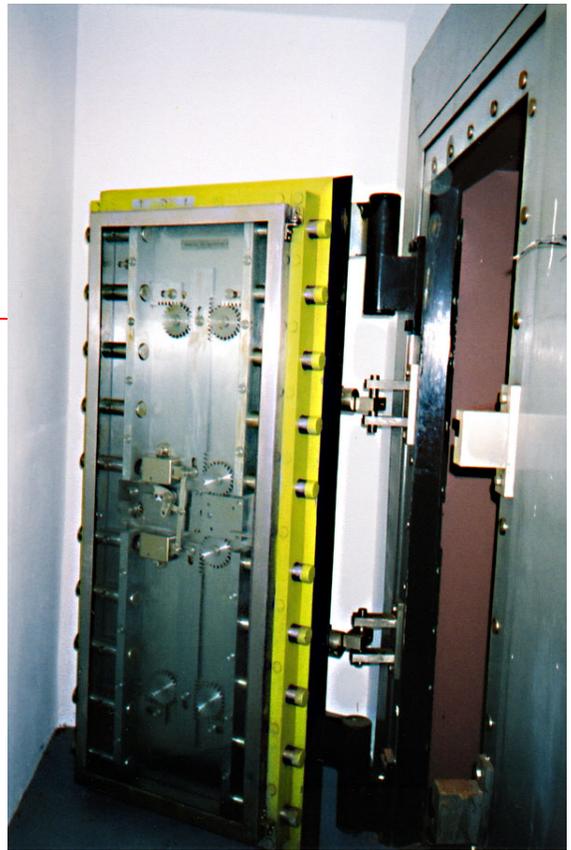
First vault door leading to interior rooms of storage area.

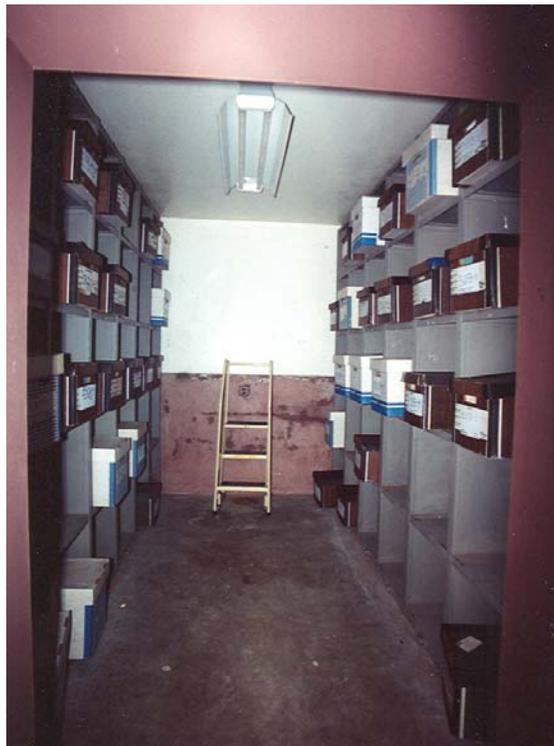
Interior rooms, each with their own vault door, with 30 inch bins.

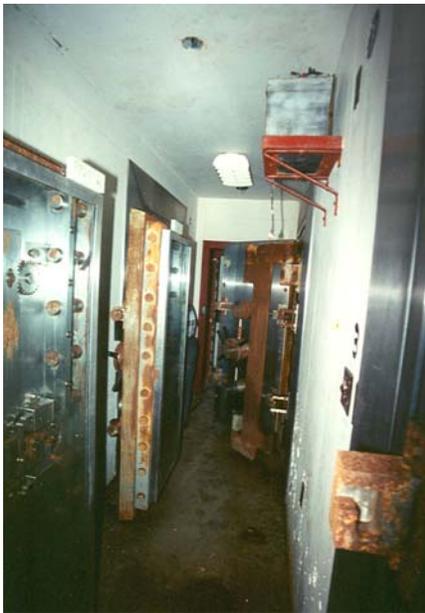
Interior vault doors in Building 941 on Stony Brook. (Sandia Site Summary, Harold Rarrick, 1994)

Each room had the capacity to store approximately 30 capsules in their storage bins. These areas are accessed through bank vault-type doors with dual combination locks. Each room contains 30 large cubicles, each about 36 inches across, to ensure "critical safe" separation of the capsules in their "bird cages".

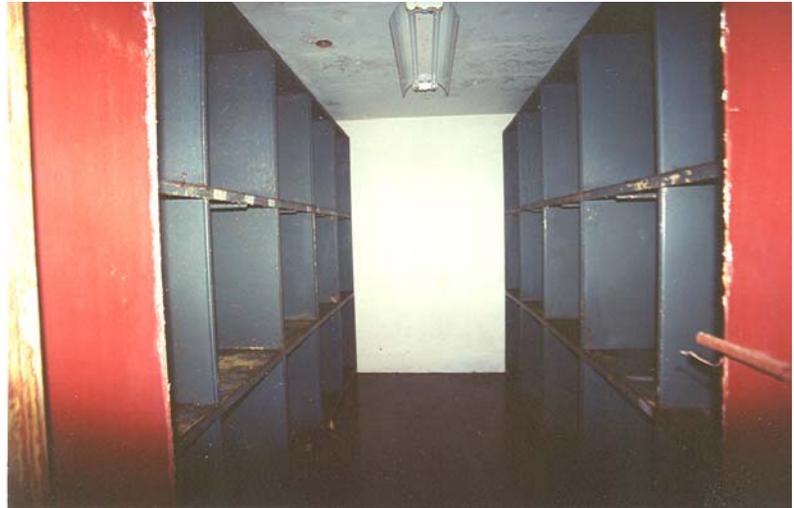
Capsule storage bins in Building 941 on Stony Brook. Note similarity to bins at Manzano Base, below. (Sandia Site Summary, Harold Rarrick, 1994)

Building 941 was the older structure on Stony Brook and was a massive concrete structure containing only 4 rooms, each about 10 feet wide, 13 feet deep and 9 feet high. It was located in close proximity to the Plant area on Stony Brook.

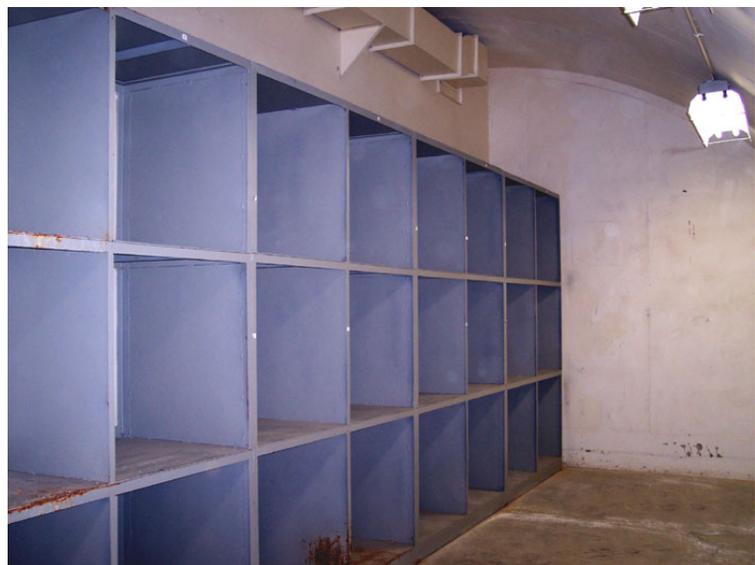
Capsule storage bins at Manzano Base, NM.

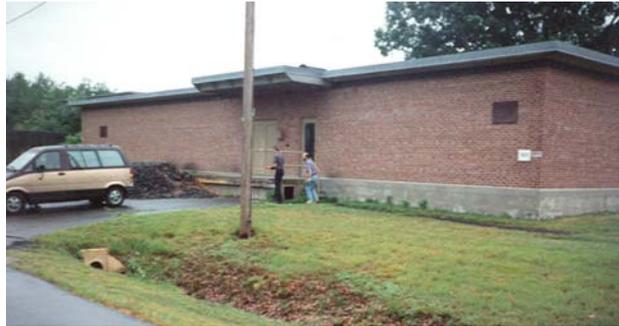
"C" Structure at Stony Brook
(Sandia Site Summary, Harold Rarrick, 1994)

The nuclear capsule maintenance activities were then conducted in the "C" Structures on Stony Brook. Before opening the bird cage, the specialists put on protective gear - a rubberized apron, respirator and latex gloves. The inspection and maintenance steps followed were:

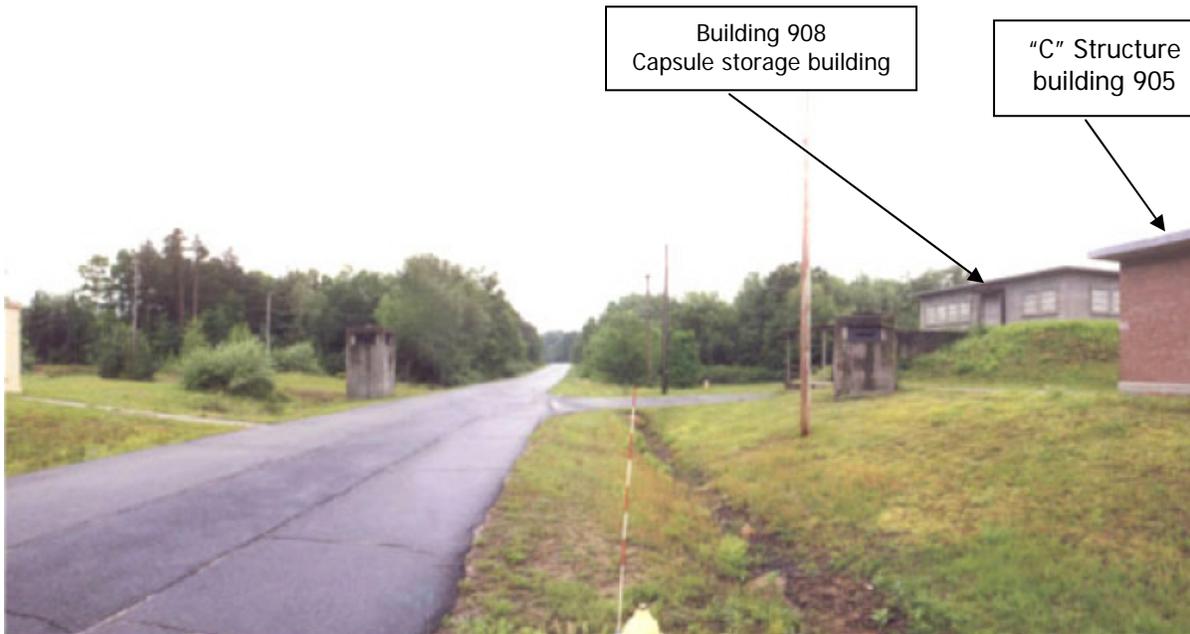
Building 905, right, the C Structure at Stony Brook. Building 908, the A Structure is shown just to the left of 905. Notice security "pill boxes" in center and on the left of road. Access road is to Plant area.
(Copyright, William Lindstrom, 2002)
